The Second Edition of European NO DIG Conference

Paper 17

HOSE LINING OF WATERMAINS ON LARGE SCALE The 'case' of Bosa Watermain, Sardinia, Italy

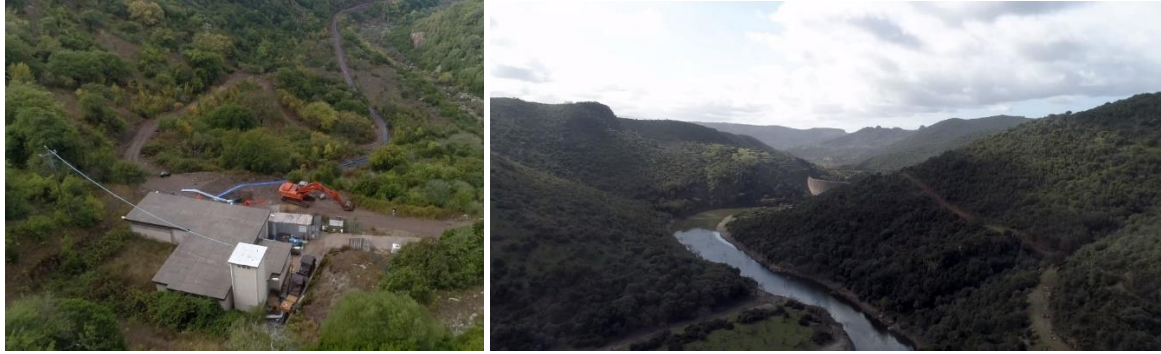
Figure 2 – Barasumene pressure divider (starting point) and Montecrispu dam (ending point)

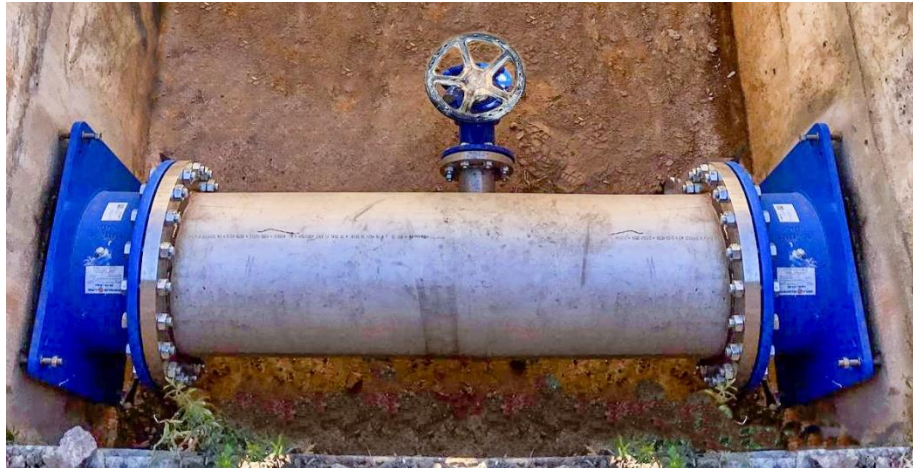
The second part that compose the Primus Line System is represented by specially developed fitting pieces: the connectors. Connectors for medium pressures pipes consist of an internal profiled core and an external sleeve. During installation, a two-component resin injected through a valve placed on the external sleeve, forces the tubular into the shape of the inner core. After the hardening time of the resin, the connection is permanent and has a high strength. Each end of the connectors is equipped with a standard flange for reconnection to the host pipe or for the insertion of fittings. Furthermore, the system always allows for the supply of customized solutions for special applications, as in the case of Bosa where the configuration for anchoring to the wall of the pit has been provided for the need to insert each connector inside the existing structures saving space.

Figure 4 – Connectors customized for pits

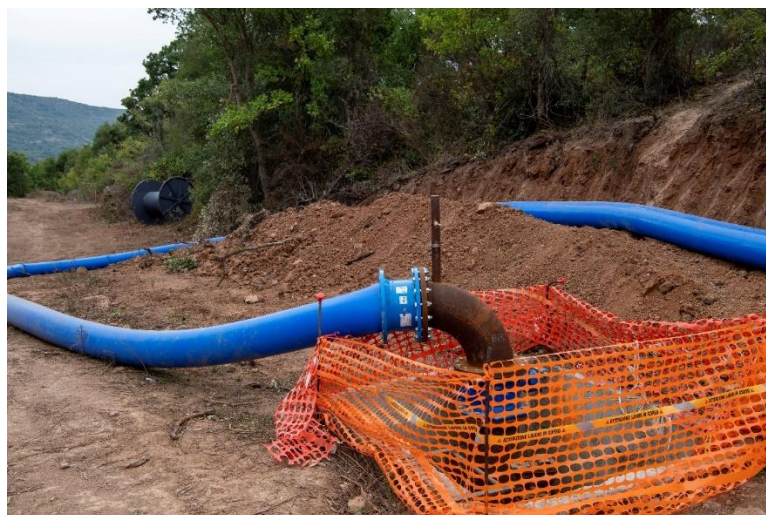
Figure 6 – Bypass installation phase

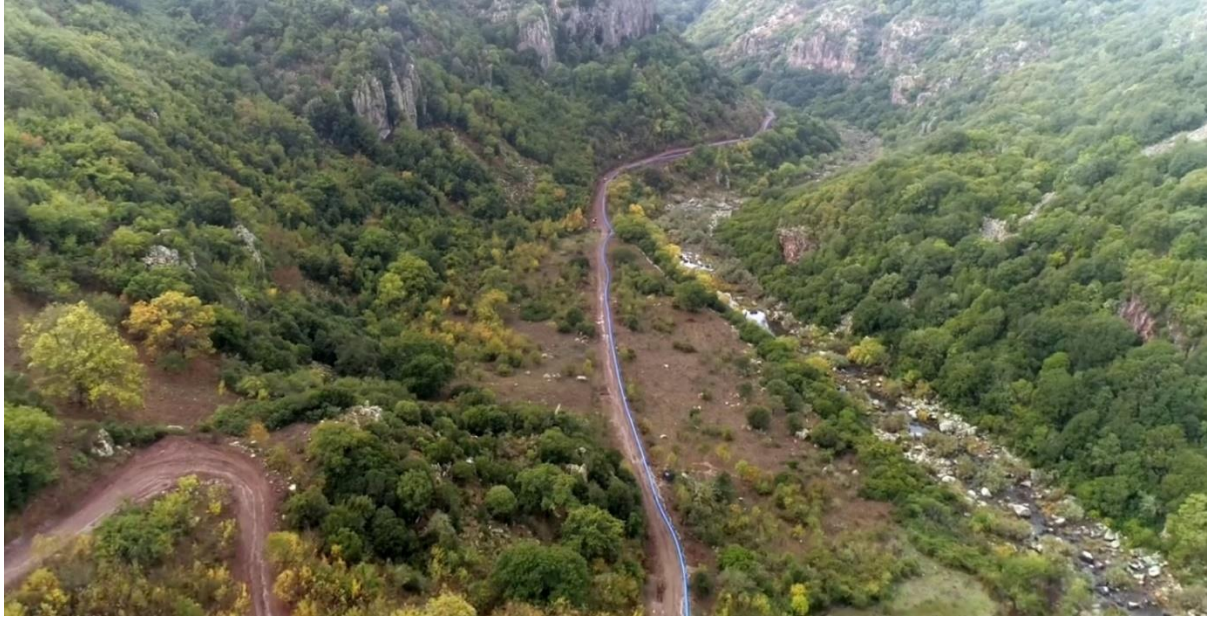
Figure 7 – Bypass view from the top

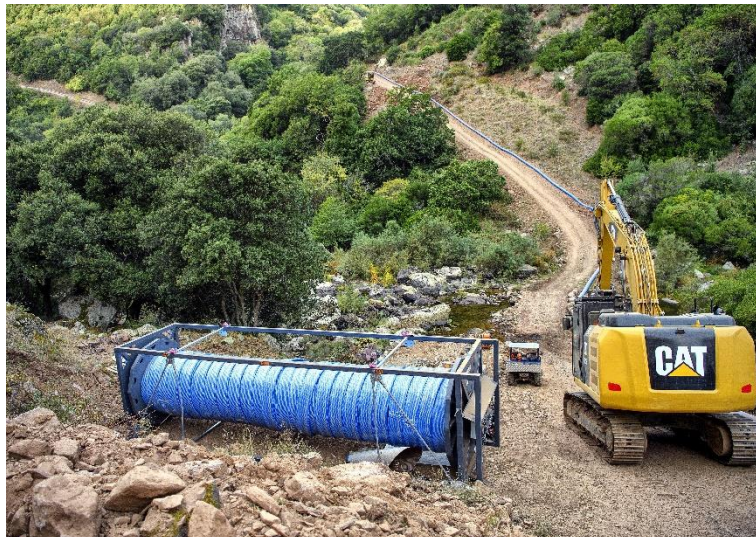
Figure 8 – Site area in correspondence of an insertion point

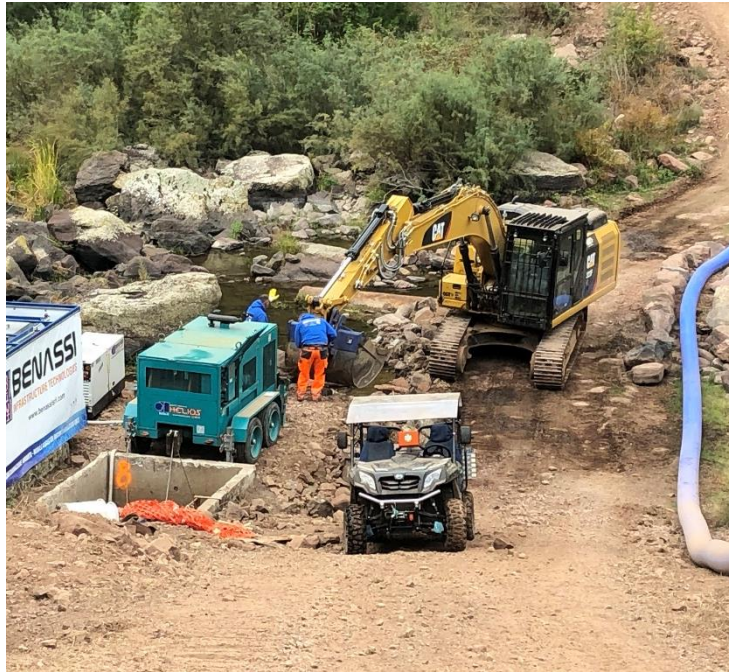
Figure 9 – Site area in correspondence of an arrival point

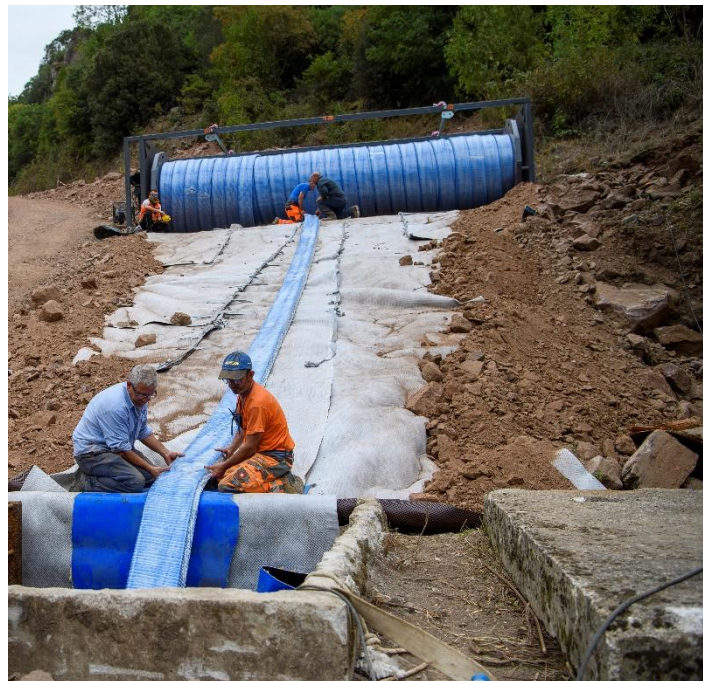
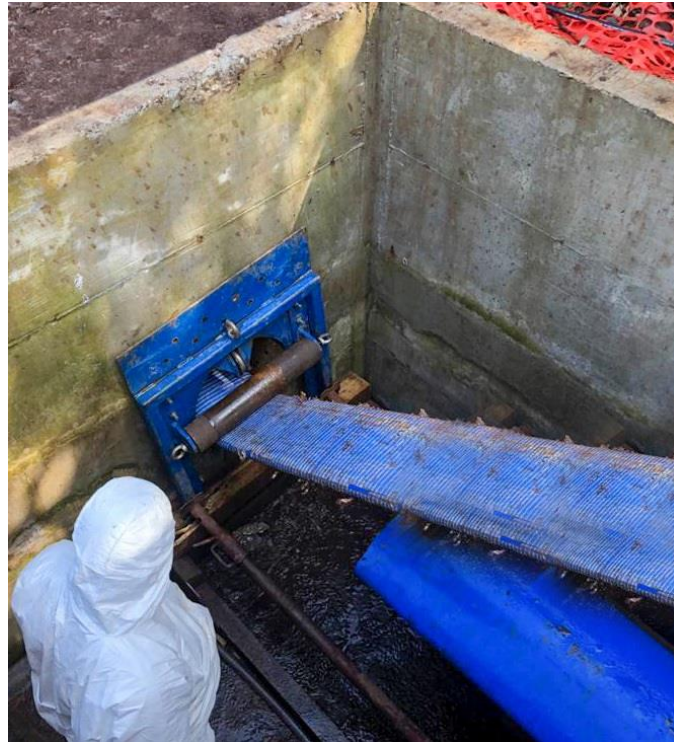
Figure 10 – Primus Line liner insertion

Figure 11 – Primus Line liner insertion

Once the suitable condition has been checked in all the sections between the bypass start/end, the Primus Line liner was inserted, and the relative connectors were installed inside each intermediate pit. The high specialization of the staff together with the quality of the high-performance equipment used by the trenchless division of Benassi, have allowed the execution of single insertions with a length of 1 km. Preliminarily to each insertion, a feasibility check was carried out by the company's technicians together with the material producer taking into account the friction forces developed along the path.

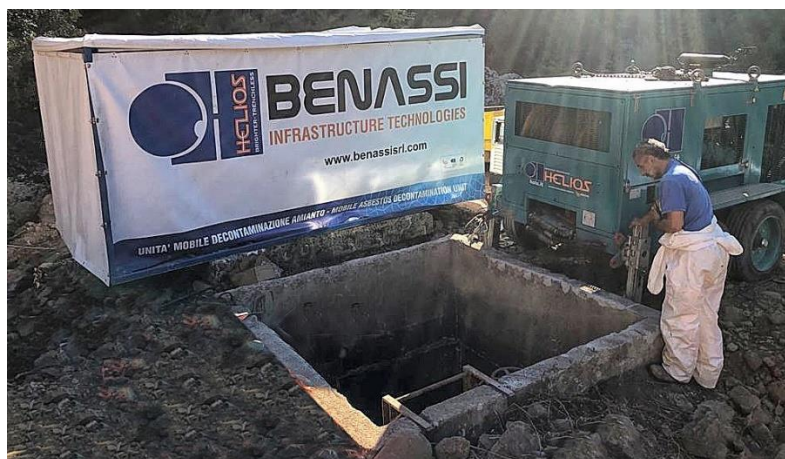
Figure 12 – Asbestos decontamination unit

Given the type of material constituting the host pipeline, particular care was given to plan the operations on underground parts of the pipeline, carried out by duly trained personnel, as well as to the limitation of the dispersion of asbestos fibers during all phases of rehabilitation with no-dig technologies. Benassi has made available a unique equipment that allows to prevent the risk of dispersion of asbestos fibers caused by the sliding of the winch cable on the walls of the pipeline during the insertion of the Primus Line liner. The equipment in question consists of a mobile purification plant that performs the cleaning of the cable immediately at the exit from the pipe at the end of the section being renovated.

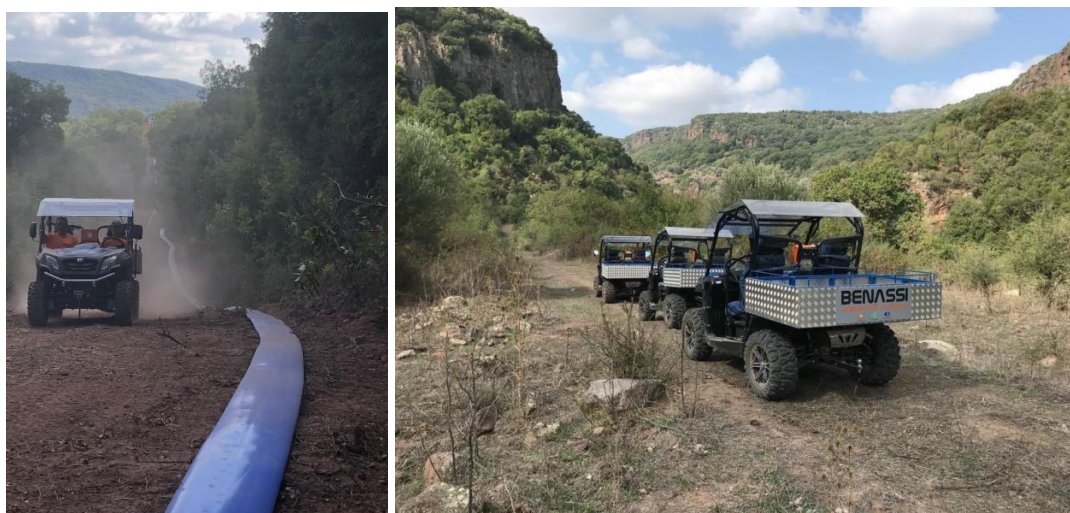
Figure 13 – Use of customized equipment for the difficult logistic conditions
