## The Second Edition of European NO DIG Conference

Paper Ref 27

# CONSTRUCTION OF A COLLECTOR SEWER IN ROME, BY MICROTUNNELING IN GEOLOGICALLY COMPLEX SOLIS AND IN AN URBAN CONTEXT OF PARTICULAR ENVIRONMENTAL AND ARCHAEOLOGICAL VALUE

E. Rizzi<sup>1</sup>, and A. Guerini<sup>2</sup>

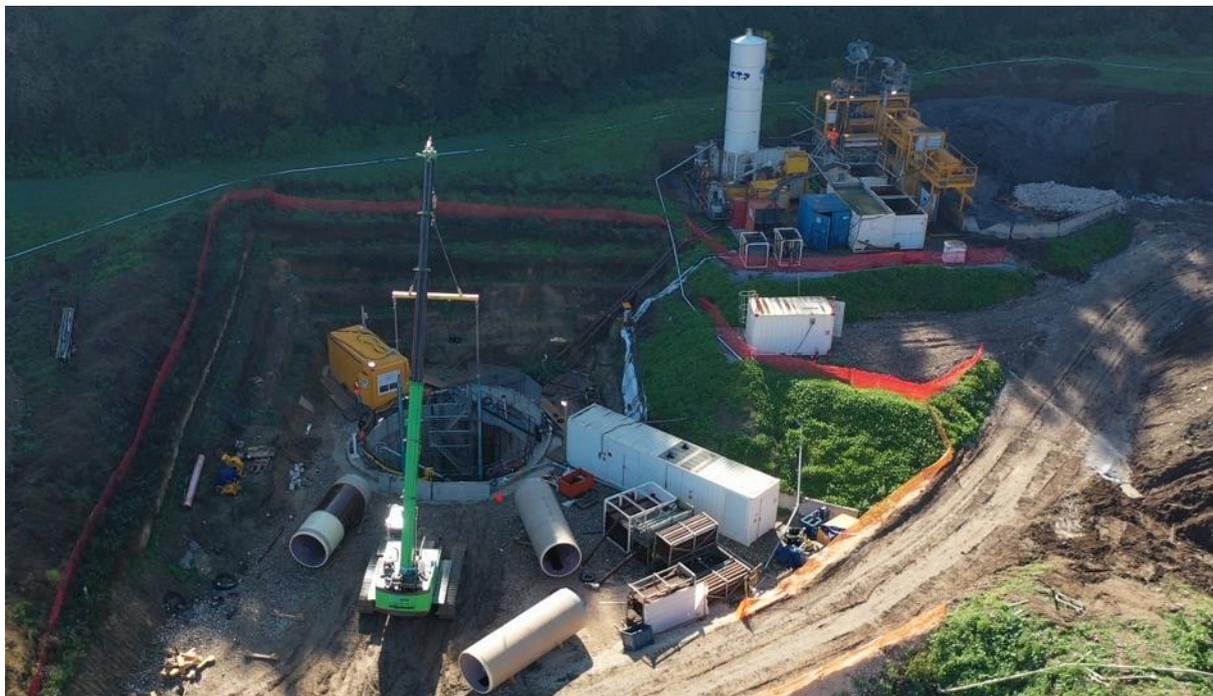
**Figure 2 – Top view of the construction site area of Section B-C**

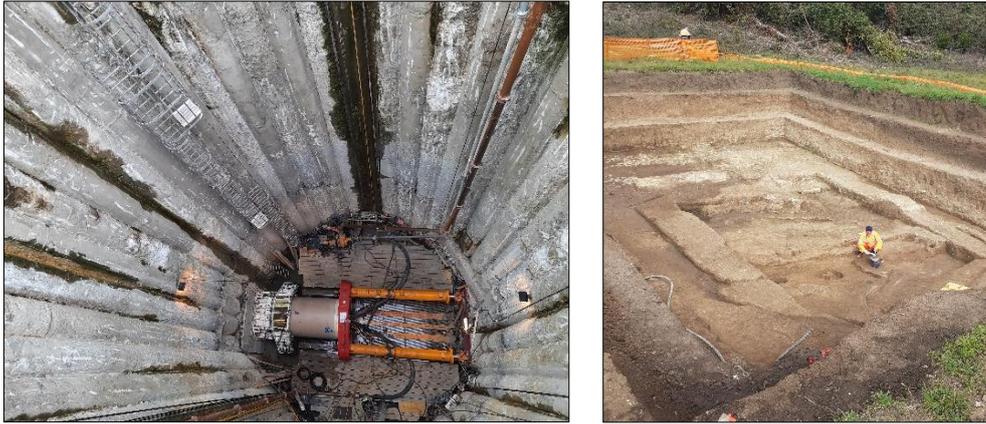
**Figure 3 – Top view of shaft D, depth 25m (left), and archaeological excavation at shaft C (right)**

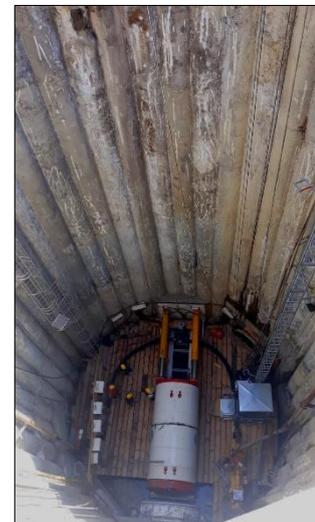
Figure 5 – Top view of shaft D, depth 22m

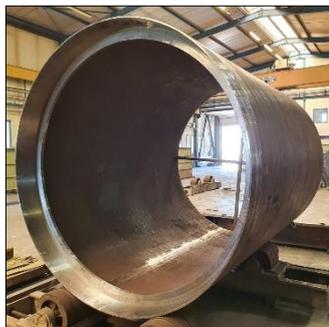
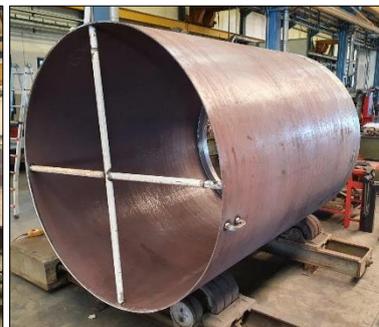
**Figure 7 - 3D view of an IJS (left), coupling side of the steel cylinder (centre) and detail of the metal cross (right)**

1. Lead Pipe: element connecting to the front of the metal piece;
2. Lag Pipe: male element inserted after the intermediate jacking station, which remains steady during jack extension and retraction and seals to the IJS thanks to its head gasket on which the metal casing slides;
3. Interjack Adaptor: adapter ring intended to transfer the jacking force from the jacks to the pipe, and compensate for the dimensional differences between the two;
4. Interjack Active Seal: ring provided with gasket, intended as an additional measure to prevent any leakage from the gasket of the Lag Pipe;
5. Steel cylinder: a metal piece which is the mobile part of the IJS. A metal cross is installed to avoid deformation during transport.

The design and manufacturing of the steel cylinder was particularly critical, as this element should both ensure water tightness, because of the high hydraulic pressure at the joint, and allow operational activities.

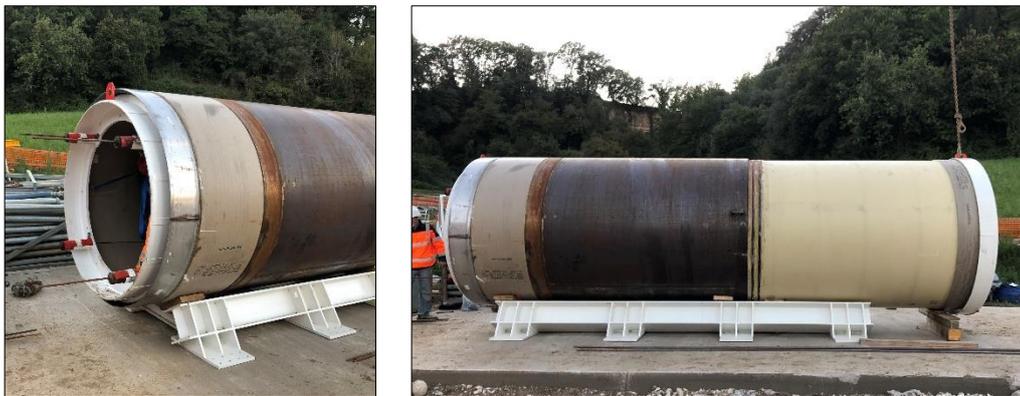
Figure 8 – View of the jacks and dywidag bars (left) and IJS assembled laying on the tracks (right)

A prototype was therefore manufactured and tested for the assembly of an IJS in order to check the functionality of the elements and establish the correct on-site assembly method. The resulting operating procedure provided for the use of a base frame on which the elements (lead pipe, steel cylinder and lag pipe) should be positioned; after assembling the adapter rings, they were connected by sliding them on the track by means of jacks and dywidag bars.

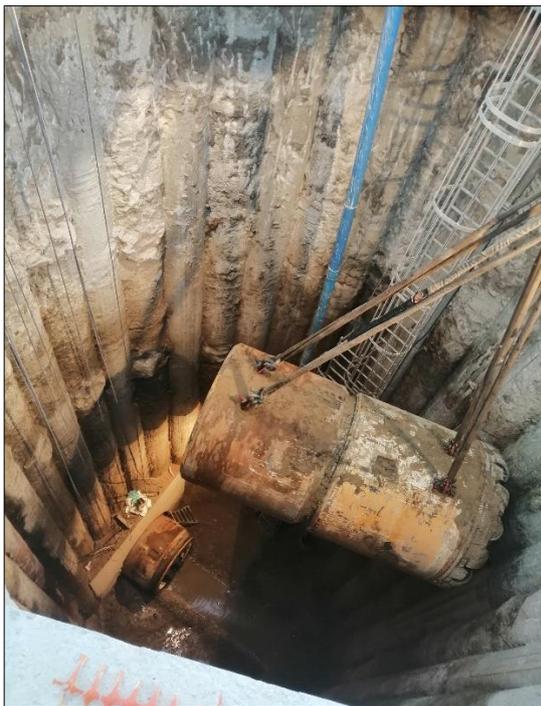
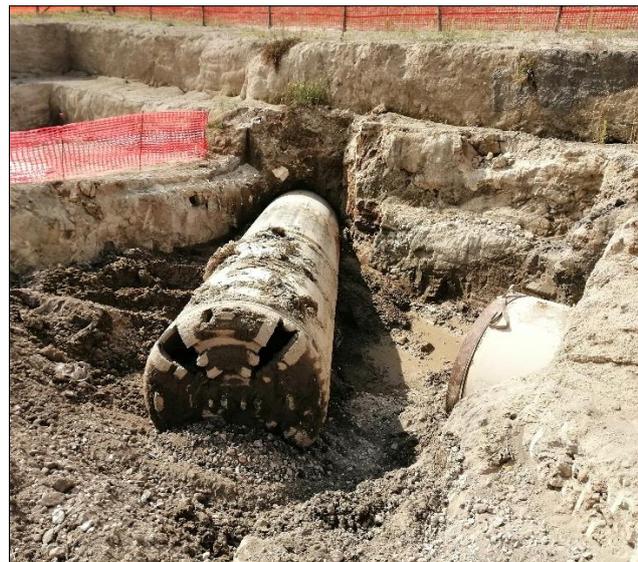
**Figure 14 – TBM recovery from the shaft E (left) and the arrival of the TBM in the archaeological excavation of shaft C, at the completion of the Section D-C drive (right)**
